PRELIMINARY ASSESSMENT

Southern Pacific Transportation Company

1301 E. Harrison Avenue

August, 29 1990

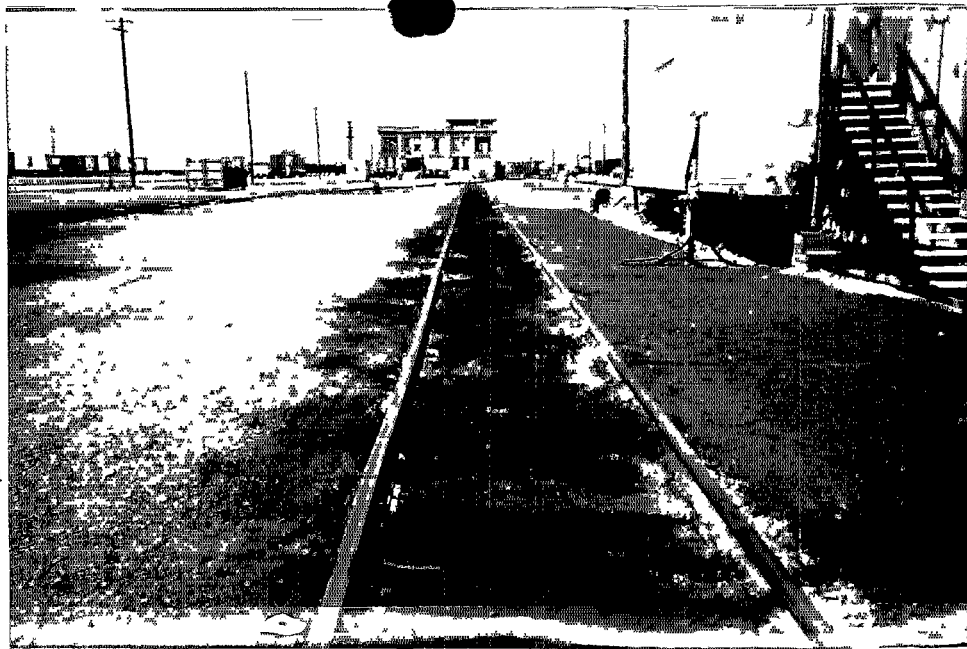
There have been no documented releases to groundwater associated with the SPTco site. Photographs indicating significant soil staining (Appendix B) show a release to soil. Since the stains have accumulated over many years (1,2), there is a good possibility of a release to groundwater. The actual source of these stains is undocumented. They are obviously related to railroad operations. The stains indicate poor containment and potentially leaking containers and/or tank cars.

Soil staining on tracks in the Southern Pacific Switching yard.

A more intensive investigation of the site would be useful in completing a more accurate assessment of the facility. Information that should be obtained includes a current map of the facility, current and historic lists of materials used, and historic activities concerning the roundhouse and other structures no longer on-site. Soil samples should be taken from the stained areas shown in the photos and similar areas on-site.

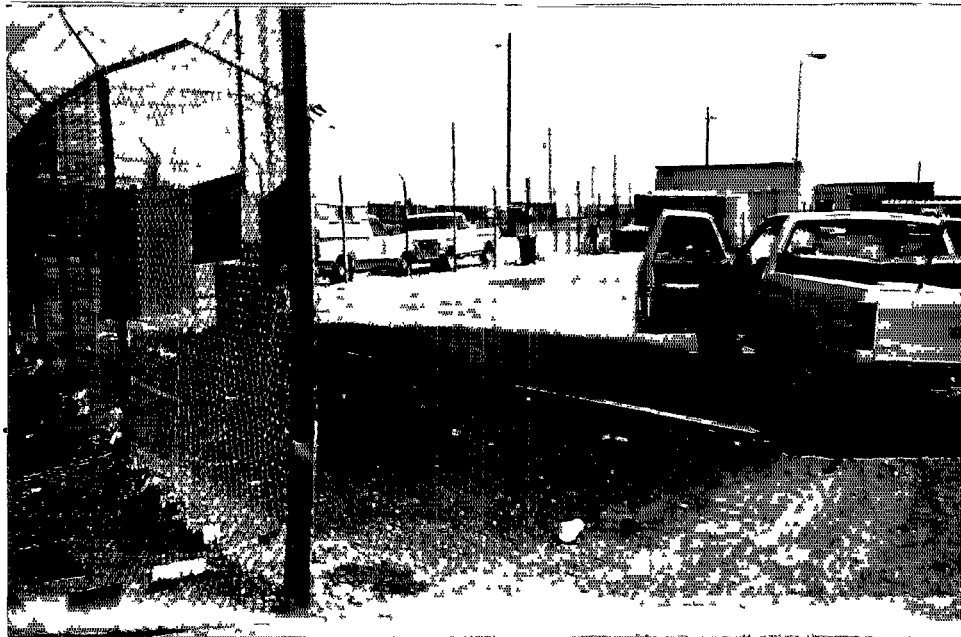
A stained section of earth in the equipment maintenance yard of the Southern Pacific Facility.
